Historic Structures Report

De Pere Lockkeeper's House Government Island De Pere, Wisconsin

Jennifer L. Lehrke, AIA, LEED AP LJM Architects, Inc. 813 Riverfront Drive Sheboygan, Wisconsin 53081

September 2011

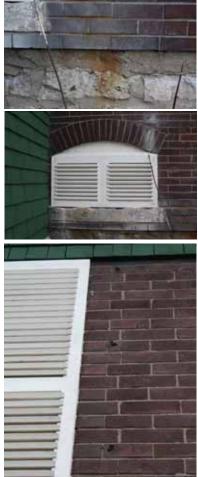
The above grade walls are comprised of red brick and grey mortar, with the exception of the walls of the Back Porch which are green painted wood shingles. All of the wall materials are in good condition as a result of the 2010 stabilization project. Several corrective measures were identified:

- Remove rust stains and miscellaneous paint splatter from brick west of the Back Porch.
- Repair or replace chipped and spalling stone sill at basement window west of the Back Porch.
- Remove paint splatter from stone sill at Kitchen window west of the Back Porch.

- Remove three metal brackets and screws along the west side of the Kitchen window west of the Back Porch and repair masonry.
- Remove miscellaneous paint splatter from brick east of the Back Porch.
- Remove paint splatter from stone sill or repaint stone sill at Dining Room window east of the Back Porch.

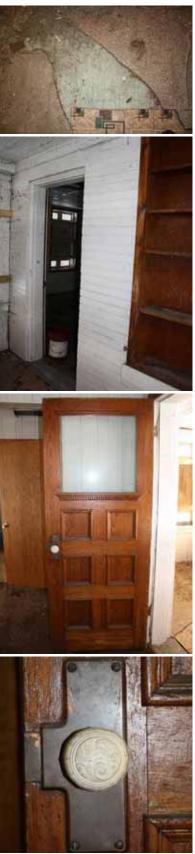
The door to Front Porch 101 is indicated on the attached schematic plans as Door 3. It is a 2'-10"x7'-0" solid wood, stile and rail style door with six square flat panels and a 24-inch square light. Corresponding to those shown on the original plans, it appears to be an original door with original door hardware. The door is stained and sealed on the Front Porch side. From what can be seen on the Front Porch face, the door appears to be in fair condition. The Front Porch side of the door is trimmed with a painted wood brickmold which corresponds to the original plans. While the wood appears to be in good condition, the paint is cracking and deteriorated. This brickmold should be properly scraped, prepped, and repainted.

There is a former window opening in the north wall of this room to the east of the door. Likely when Hall 102, Bath 104, and Front Closet 110 were reconfigured and remodeled in 1973-1974, the original window sashes were

removed, and a stained and sealed five-shelf bookshelf was installed in its place. If the space is reconfigured back to its original condition, the bookshelf should be removed, and the window opening should be restored back to its historic appearance based on the original drawings and other extant window openings. There are eight window openings in this porch enclosure walls, two in the east, four in the south, and two in the west. Similar to the other windows, the sashes were removed and stacked neatly with the others in the vicinity of Dining Room 106 during the 2010 stabilization work, and the openings were outfitted with painted wood shutters with ventilation holes. There is simple, painted 1x4 wood trim around each of the window openings; some of the pieces are missing. As these windows date outside of the house's period of significance, it is recommended that they be removed so the at the porch can be accurately replicated to its original, open condition based on the 1911 blueprints and photographic evidence.

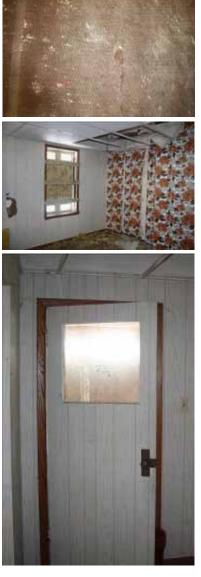
In addition to the description found in Front Porch 101, Door 3 has been sheathed in a piece of type 1 paneling on the Living Room side. The paneling should be removed to better assess the condition of the door. Similar to most of the other doors of the house, the Living Room side of the door has been retrofitted with a stained and sealed ranch style casing which was installed between 1973 and 1974. This trim should be removed and replaced with new stained and sealed wood trim which corresponds to the original drawings and matches the component profiles at Door 7.

There are two 2'-9"x5'-3" window openings in the Living Room, one in the south wall and one in the west. Similar to the other windows, the sashes were removed and stacked neatly with the others in the vicinity of Dining Room 106 during the 2010 stabilization work, and the openings were outfitted with painted wood shutters with ventilation holes. Similar to other window openings of the house, the windows has been retrofitted with a stained and sealed ranch style casing which was installed in 1973-1974. This trim should be removed and replaced with new stained and sealed wood trim which corresponds to the original drawings and matches the component profiles at the window in Hall 201.

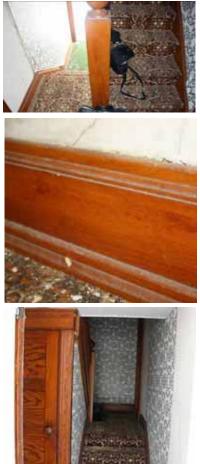
All of the walls of Stair 105 consist of wallpaper over painted plaster. Due to the number of layers of paint underneath the wallpaper, it would not seem to be original to the building and should be removed to better assess the condition of

the plaster below. From what can be seen of the plaster where the wallpaper has peeled off of the walls, it is in poor to fair condition, and mold is evident. The plaster should be repaired where necessary, prepped, and repainted a dark tan color (Sherwin Williams SW 6123 Baguette or Munsell 2.5Y 6/4) which was found during the paint analysis.

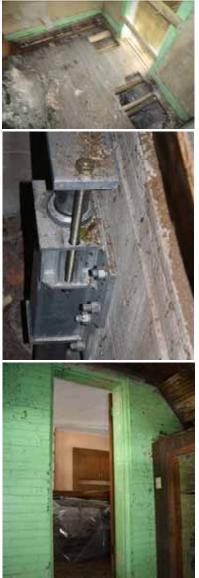
The door from Dining Room 106 to Back Porch 109 is indicated on the attached schematic plans as Door 10. It is a 2'-6"x7'-0" solid wood, stile and

rail style door, stained and sealed, with three flat panels oriented horizontally and a 20-inch by 26-inch divided light. Corresponding to those shown on the original plans, it appears to be an original door. It is in fair condition. If the future use of the house remains residential in nature, the door should simply be repaired where necessary, sanded, prepped, and refinished. If the building is converted to commercial purposes, the door may need to be replaced with a similar wider door to allow for accessibility throughout the first floor. The hardware is of a newer vintage and should be replaced with something more historically appropriate. Similar to the Front Porch, the Back Porch side of the door is trimmed with a painted wood brickmold which corresponds to the original plans. While the wood appears to be in good condition, the paint is cracking and deteriorated. This brickmold should be properly scraped, prepped, and repainted. The Dining Room side is a stained and sealed ranch style casing which should be removed and replaced with new stained and sealed wood trim which corresponds to the original drawings and matches the trim profiles at Door 7.

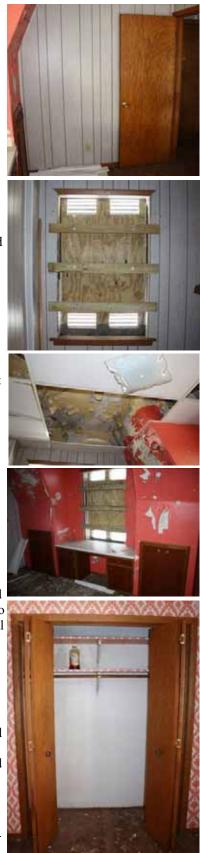
All of the walls of Closet 203 are painted plaster which is in fair condition. The plaster should be repaired where necessary, prepped, and repainted a gray-

green color (between Sherwin Williams SW 6199 Rare Gray & SW 6200 Link Gray or Munsell 5GY 6/1) which was found during the paint analysis.

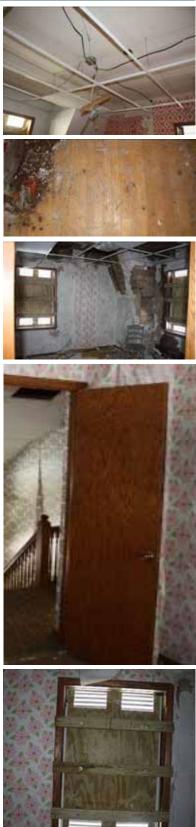
Similar to the other bedrooms, there are two 3'-0"x4'-8" window openings in this bedroom, one in the north wall and one in the west. The sashes were removed and stored during the 2010 stabilization work, and the openings were outfitted with painted wood shutters with ventilation holes. They have been retrofitted with stained and sealed ranch style casing that should be removed and replaced with new stained and sealed wood trim which corresponds to the original drawings and matches the trim profiles of the window in Hall 201.

Similar to all the other rooms on the second floor, the existing ceiling consists of a few 2x4 fiberglass ceiling tiles in a suspended metal grid dropped approximately one-foot below a painted plaster ceiling. The ceiling tiles and grid should be removed. The plaster ceiling is in very poor condition and what remains of the plaster is in very poor condition and should also be removed. The ceiling should be insulated, receive a vapor retarder and gypsum wallboard, and should be painted a white color.

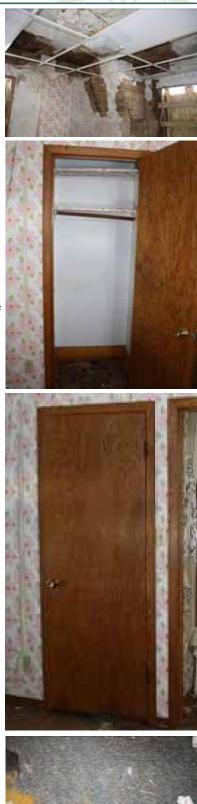
The extant stained and sealed ranch style base should be removed and replaced with new stained and sealed wood base with shoe moulding based on the component profiles found in Closet 207.

The west, south, and east walls of the Northeast Bedroom consist of paneling type 1 over painted plaster, and the north wall is painted plaster. The paneling should be removed to better assess the condition of the plaster which is assumed to be in poor shape based on the existing conditions in other rooms. The plaster on the west, south, and east walls should be repaired. However, the plaster on the north wall is in very poor condition, much of it has already fallen off of the lath, and it should be removed altogether. The north wall should be insulated, a vapor retarder applied, and a new layer of gypsum wallboard. Then the entire room should be repainted a dark green color (Sherwin Williams SW 6194 Basil or Munsell 10G 5/2) which was found during the paint analysis.
