**Broadway Street Pedestrian Safety Study  
Cass Street to 700 Feet North of Randall Avenue**

**Prepared for:  
City of De Pere, Wisconsin**

**Prepared by:  
**AYRES**  
ASSOCIATES**

**June, 2017**

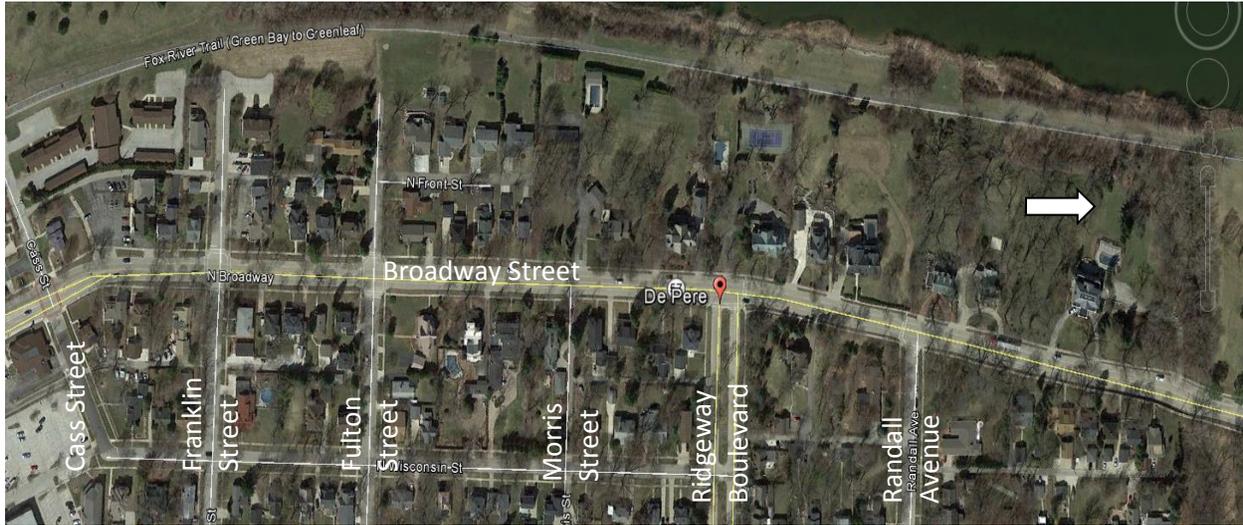
**Figure 1: Broadway Street Pedestrian Safety Study Corridor**

For reference purposes, Figure 1 shows the study segment of Broadway Street.

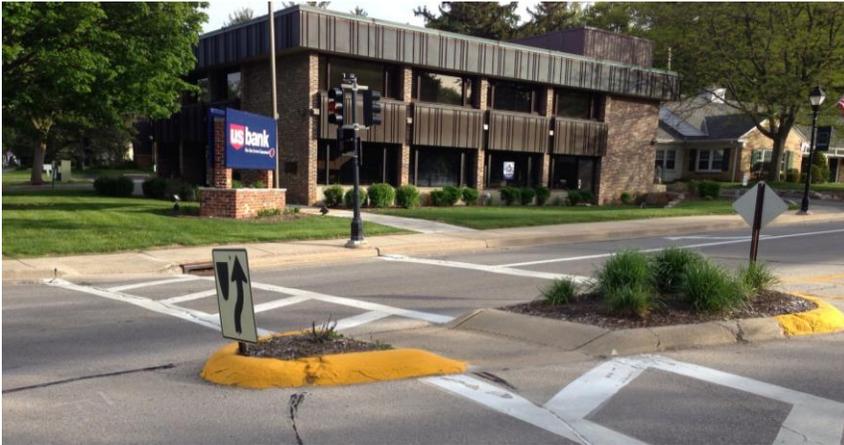
**Figure 4: Typical Pedestrian Median Refuge Island**

Figure 4 shows a typical median pedestrian refuge island design. Median pedestrian refuge islands can be constructed with a minimum width of 4-feet to provide a protected area for pedestrians crossing a street. It is desirable to provide a 6-foot median width to maximize safety for groups of pedestrians and children crossing a street.

Construction of pedestrian median refuge islands serve two major purposes. The first purpose of a pedestrian median refuge island is its ability to allow a pedestrian to find a gap in one direction of traffic at a time as compared to requiring a 'combined' two-way gap to safely cross the street. The second purpose of a pedestrian median refuge island is to reduce traffic speeds by providing a physical indication of a narrow traffic lane on the driver's side of a vehicle. The cost of reconstructing a pedestrian median refuge island on Broadway Street is estimated at \$25,000 each as it requires a minimum 2-foot set-back of the existing curb approaches to the intersection.

This traffic management measure, based on existing traffic gap data, is considered an important tool for enhancing pedestrian safety on Broadway Street.

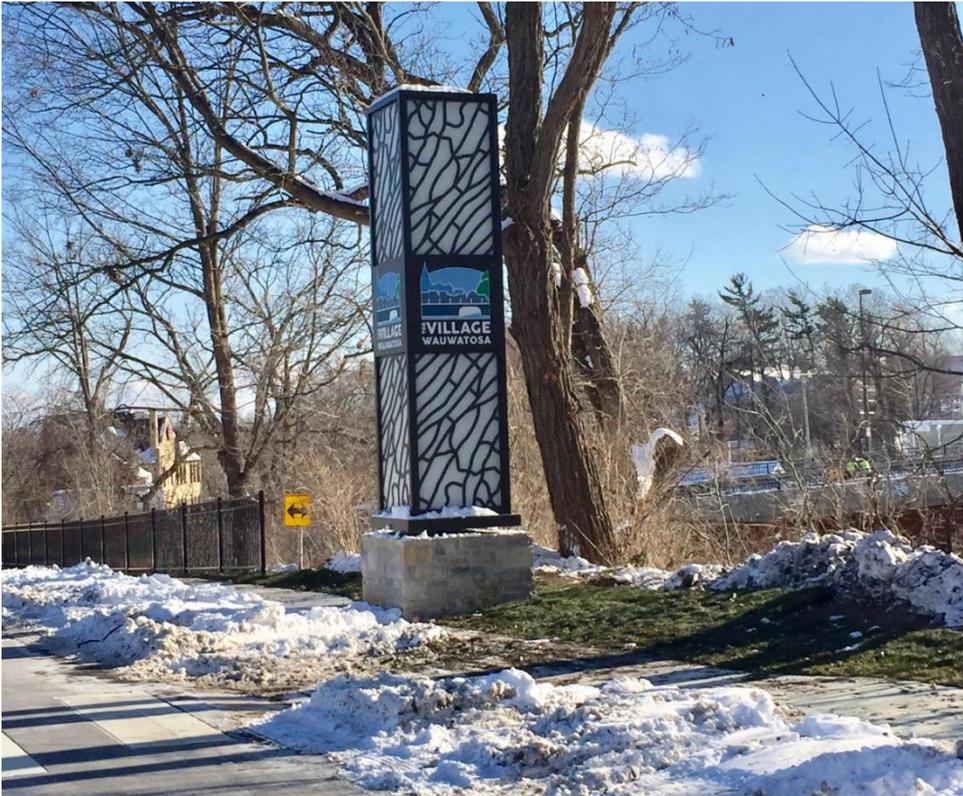
**Figure 5: Gateway Column Example**

Gateway treatments usually consist of enhanced ground mounted signs, landscaping treatments or physical columns located adjacent to a street edge or median to notify drivers that they are entering a higher pedestrian urban area context to reduce speeds. Figures 5 and 6 illustrate gateway treatment examples. The cost of gateway construction can range from \$20,000 to \$50,000 depending on the complexity of the design.

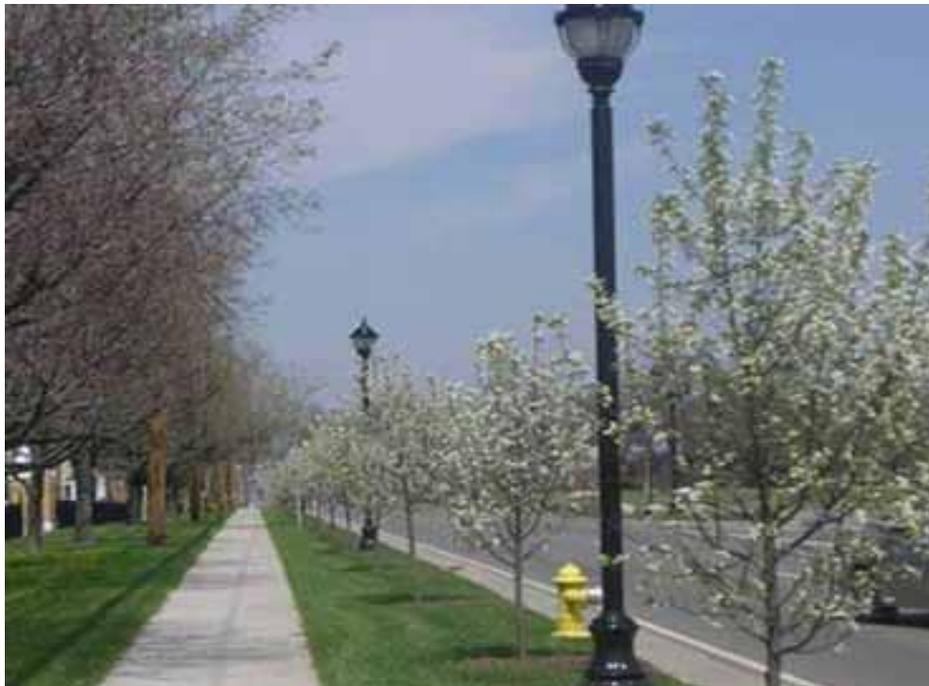
**Figure 7: Urban Street Landscaping Example**

One of the most noticeable impacts to a drivers' perception of reasonable driving speeds involves the presence of landscaping along a street or in the median. Figure 7 illustrates an urban street landscaping design.

Landscaping treatments affect a motorist's sense of comfort and appropriate speed as well as its ability to enhance the pedestrian friendliness atmosphere of a street. The majority of Broadway Street is lined with mature trees except for the segment north of the study limit. The cost of street landscaping can vary widely depending on the extent of tree plantings and other related treatments such as flower beds and hardscape treatments.

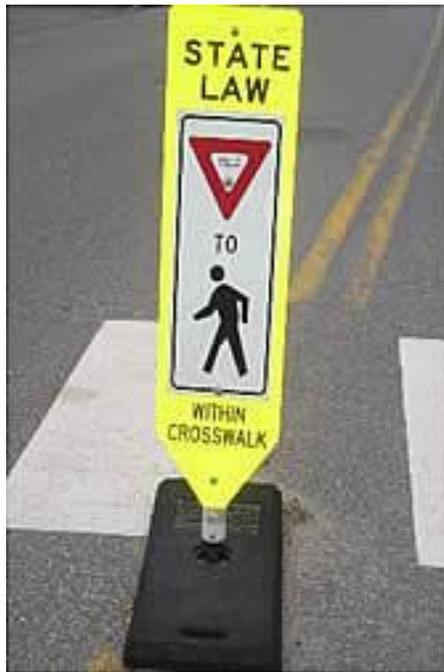
**Figure 8: In-Street Pedestrian Crossing Sign**

In-street pedestrian crossing signs, as shown on Figure 8, provide an effective tool to inform drivers of Wisconsin State Statute requirements to yield to pedestrians in a crosswalk.

In-street pedestrian crossing signs can provide an added benefit of taming traffic speeds by creating a narrow lane perception to drivers. The estimated cost per sign is \$350.

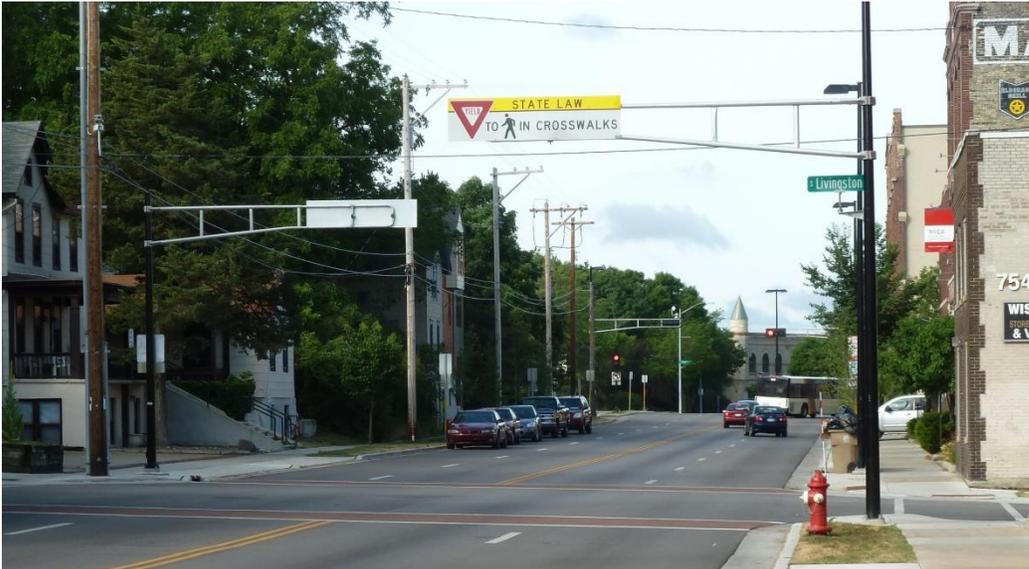
**Figure 9: Overhead ‘Yield to Pedestrians in Crosswalk’ Sign**

An additional option to the 'In-Street' sign placement (MUTCD R1-6) is to mount the sign (in this case MUTCD R1-9) on an overhead mast arm as shown as shown on Figure 9. The overhead mounting eliminates the need to remove 'Yield to Pedestrian' signs under winter weather conditions. The overhead sign placement increases sign visibility, particularly on 4-lane streets. Placement of overhead mast arm signs may present a conflict with the nature of the historic district along Broadway Street. The estimated cost per sign, including the overhead sign pole, is \$3,500.

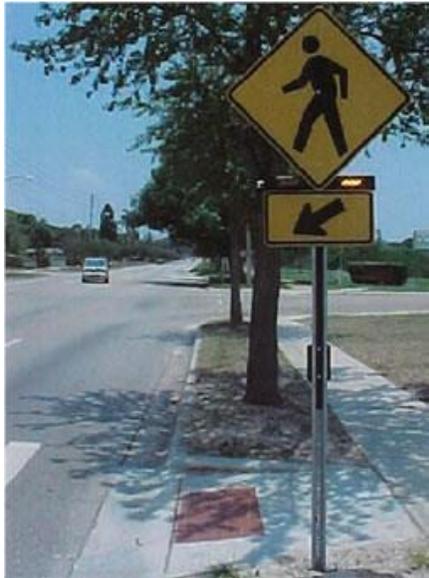
**Figure 10: Pedestrian Crossing Rectangular Rapid Flashing Beacon (RRFB)**

RRFB’s are a traffic control device that combines a pedestrian warning sign with pedestrian activated yellow flashing light diodes as shown on Figure 10. The flashing lights remain dark until activated by a pedestrian push button.

RRFB's can enhance pedestrian safety by reducing crashes between vehicles and pedestrians at unsignalized intersections and mid-block pedestrian crossings. According Federal Highway Administration (FHWA) research, installing RRFB's at a marked crosswalk can increase driver yielding to pedestrian patterns to between 80% and 100%.

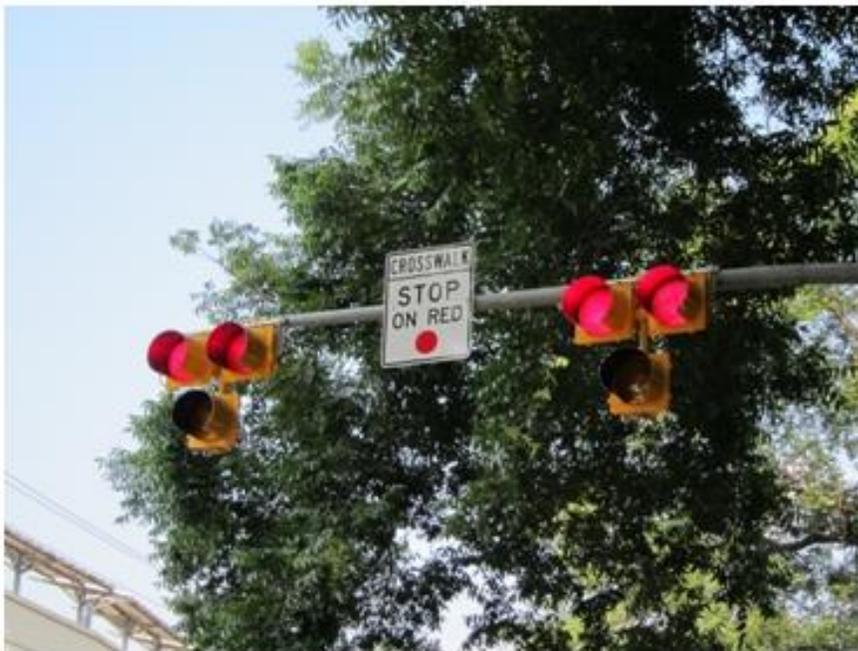
**Figure 11: Pedestrian Crossing Hybrid HAWK Beacon**

The High-Intensity Activated Crosswalk (HAWK) beacon is designed to assist pedestrians crossing high traffic volume streets. The HAWK beacon is a push-button pedestrian activated red signal that stops traffic, allowing pedestrians to cross and is shown on Figure 11.

The HAWK beacon is comprised of a yellow beacon centered below two red beacons that remain dark until activated by a pedestrian push button. Once activated by a pedestrian, the beacon flashes yellow for a few seconds, followed by a solid yellow indication with the yellow indication followed by a solid red indication during the WALK phase. At the end of the WALK phase the HAWK beacon will display an alternating flashing red indication allowing motorists to proceed after stopping and yielding to pedestrians. Once the pedestrian clearance interval is completed the beacon returns to a dark mode. The HAWK beacon only controls traffic on one side of an intersection. Side street traffic is controlled by STOP signs.

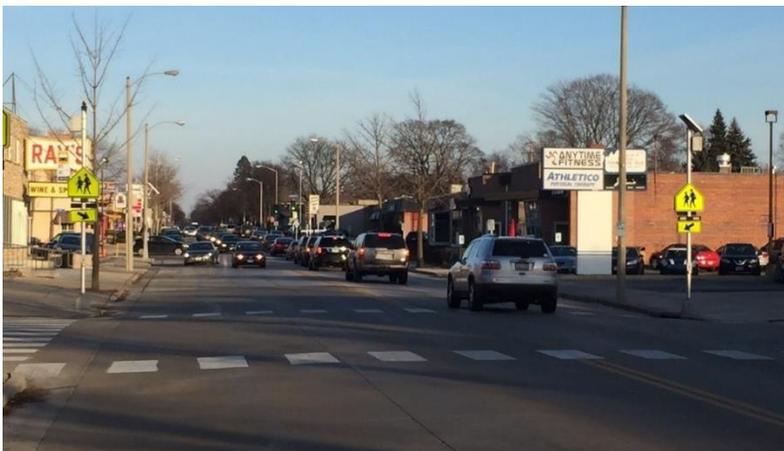
**Figure 19: Double Sided Pedestrian Crosswalk Signs**

7. It is recommended that all crosswalks on Broadway Street be signed with double sided pedestrian crossing and arrow signs on both sides of the street as shown on Figure 19.

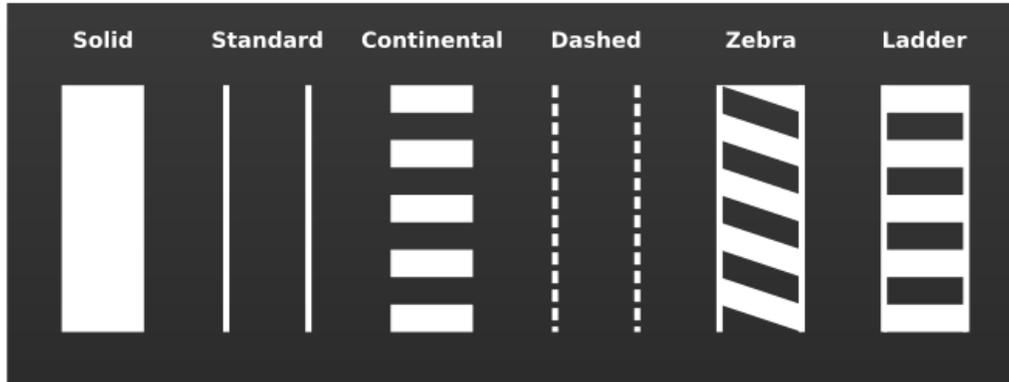
**Figure 2: Crosswalk Striping Patterns**

'High-Visibility' markings shall be used at the following locations:

- Where mid-block crossings are installed
- Across uncontrolled traffic at partial stop sign controlled intersections
- Where crossings are installed on streets having an ADT of 4,000 vpd or more
- In high pedestrian areas of business district, campuses, commercial areas where significant distractions to motorists and pedestrians are likely to occur.
- Within school zones or as shown on a school walking route plan
- When a Traffic Engineering Study indicates a need for additional visibility
- Where crosswalk treatments are used for raised pavements
